# TROUBLESHOOTER

## How to use GB Reflective no-sew skin in manufacturing

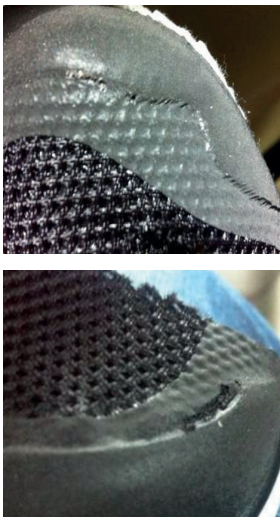
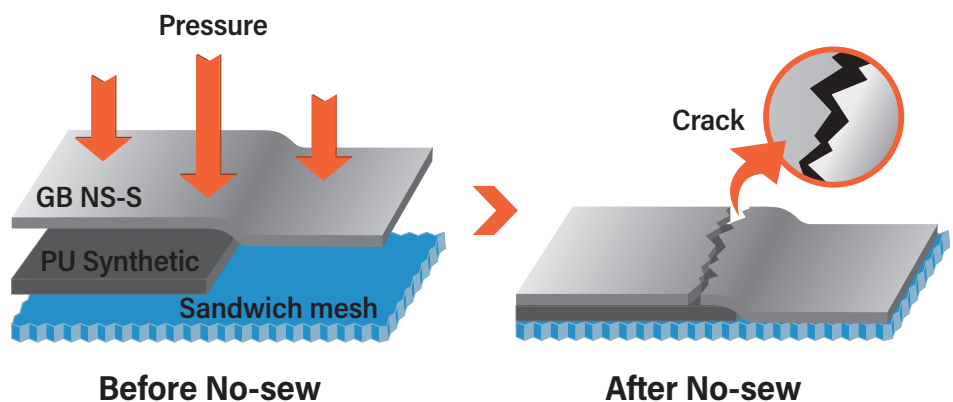
After no-sewing, the reflective surface is broken and torn.

The no-sew base material is made up of two very thick layers, which can't withstand the thickness of a 0.1mm reflective film.

For GB NS-S, the hot melt melts and only the reflective film (0.1mm) remains after no-sewing. Reflective film (0.1mm) can't withstand the synthetic PU (1.2mm) if the applied part is the edge of the PU composite backer.

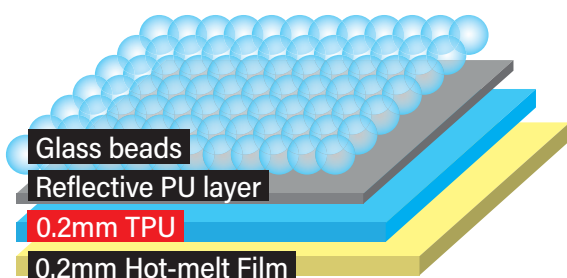
### SOLUTION 1

In this case, we strongly recommend using NS-SV2 which has 0.2mm TPU in the middle layer instead of NS-S.

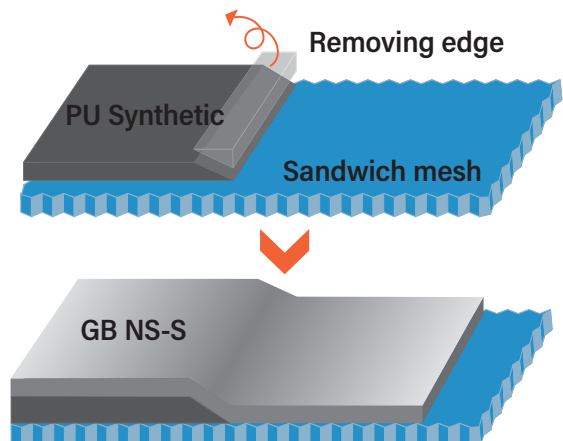
### SOLUTION 2

Skive the area where PU and synthetic leather are overlapping.

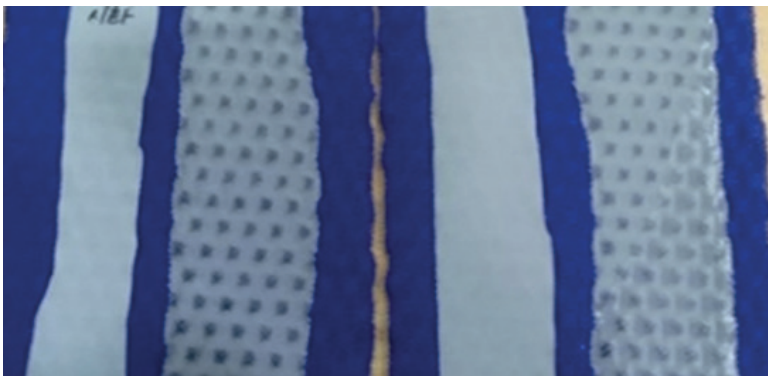
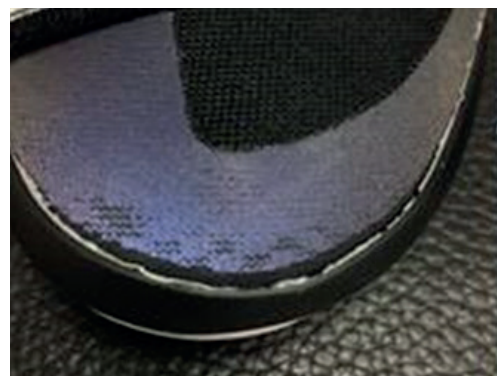
Textile pattern comes up on reflective surface and glass beads peel off.

Reflective film is too thin to withstand dynamic patterns of textiles such as Jacquard.

In case of NS-S, the hot melf film is soaked into the textile and only 0.1mm of reflective film remains. If the sandwich or jacquard mesh with a large hole is used with the NS-S, the reflective layer is broken or cracked.

If the fabric with rough pattern is the base, using NS-SV2 is strongly recommended instead of NS-S or NS-F.

NS-SV2 has TPU in the middle layer to cover the rough pattern of the fabric.

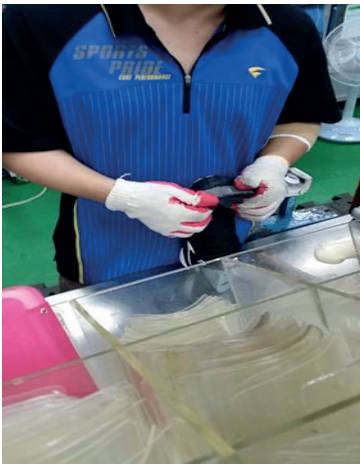
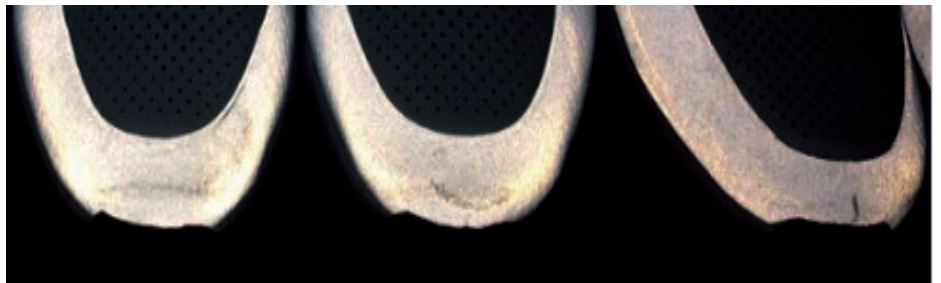
### ● EXAMPLE #1

To check the bonding strength of inside the vamp, the worker turn the upper inside-out. This process may cause wrinkles or peel-offs.

If this process cannot be eliminated, the need for attention to these factors needs to be registered on PFC or SOP.

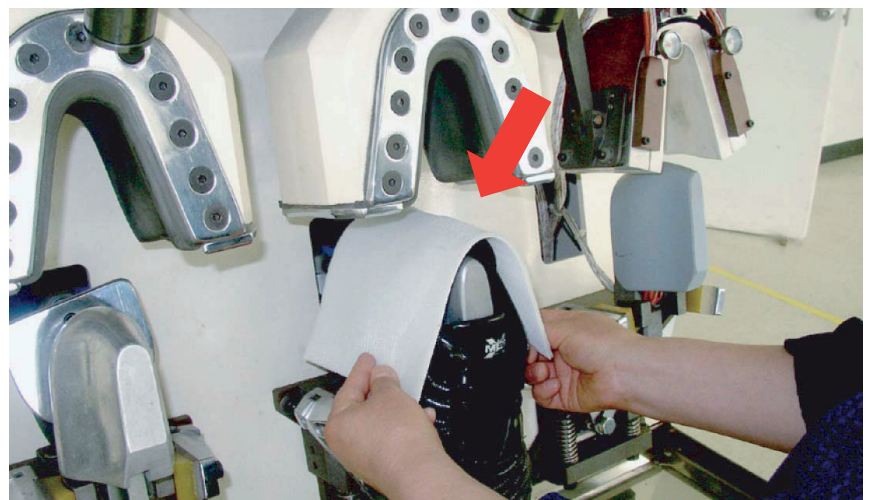
Backpart Molding

After the process of applying heat and pressure, such as No-sew or molding process, the reflective surface can easily scratch or peel off.

When the reflective surface is already affected by heat, pressure, or both, reflective surface may scratch or peel off during toe lasting, heel lasting, or outsole attachment.

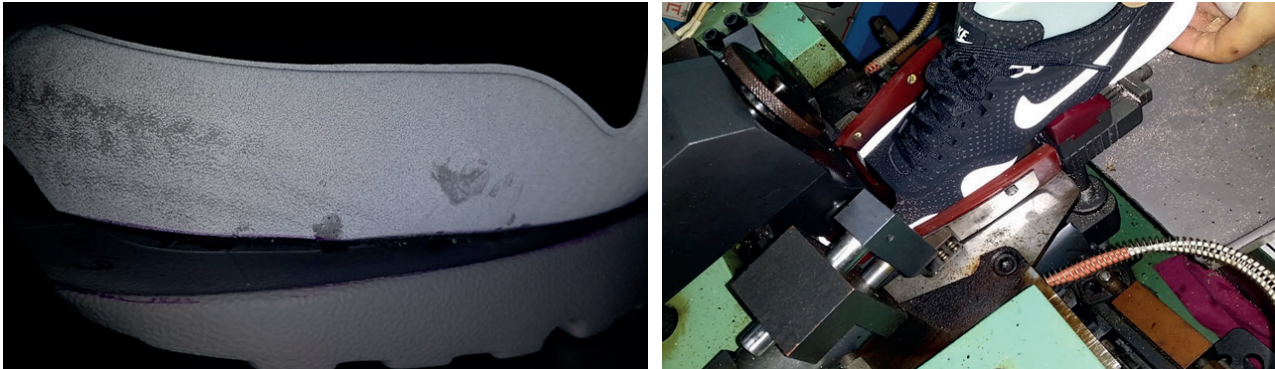
### ● EXAMPLE #2

During toe lasting, the surface gets damaged very easily.

Due to high pressure and heat during no-sew process, the reflective surface is already affected and may get damaged more easily.

To protect the reflective surface during toe lasting process, we suggest that you cover the surface with something soft such as silicon pads.

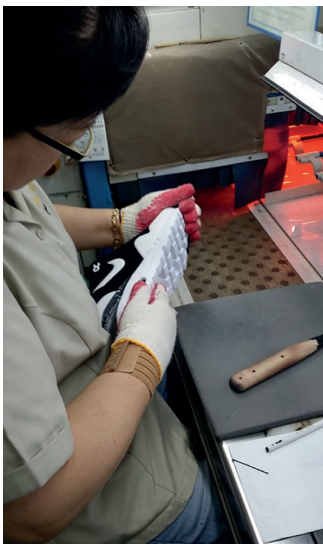
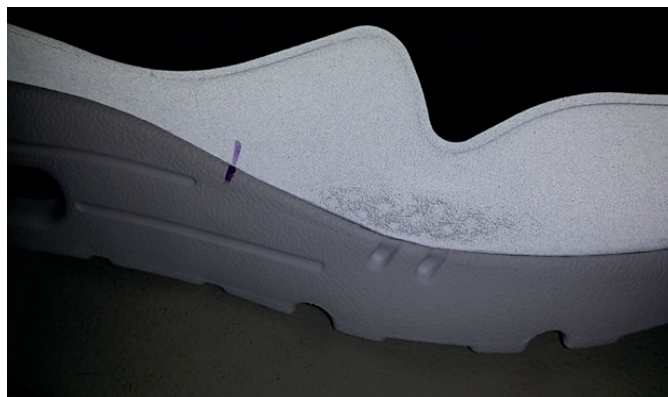
### ● EXAMPLE #3

When attaching outsoles, the workers use a wooden stick for convenience.

If not careful, the wooden stick will cause damage on the reflective surface. Most worker are not aware of properties of reflective material and they need to be told to be careful to prevent scratches.

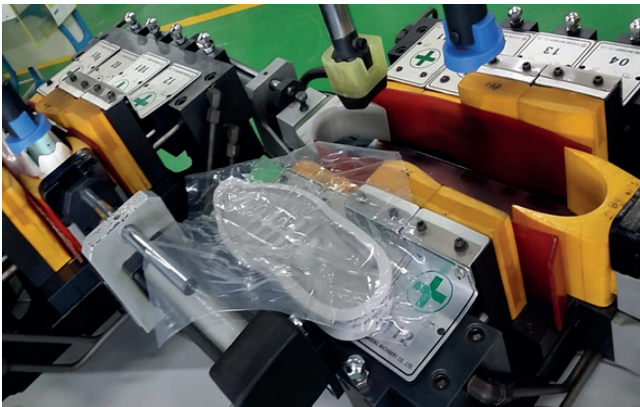
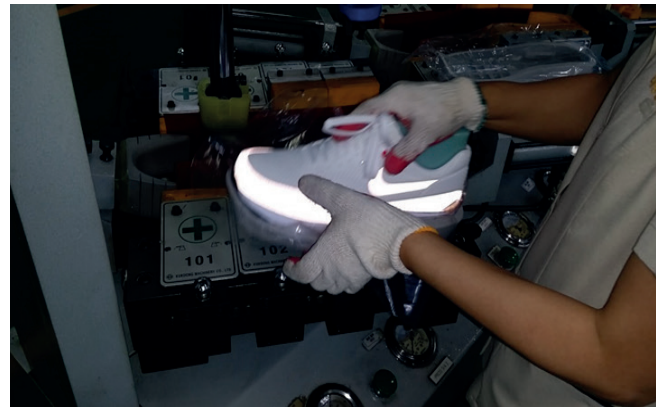
### ● EXAMPLE #4

During deep-wall press, reflective material can be damaged due to high pressure. (Especially the tip or mudguard)

In order to protect the reflective surface, the workers should cover shoes with soft silicon pad or vinyl.

Also, if possible, shoes need to be processed in size groups to minimize the friction.
